# SPEED PROGRAM DEMONSTRATION FOR SEALING DUCT LEAKS USING AEROSEAL

*The Art Building  
UC Davis, CA*

*March 19, 2014*

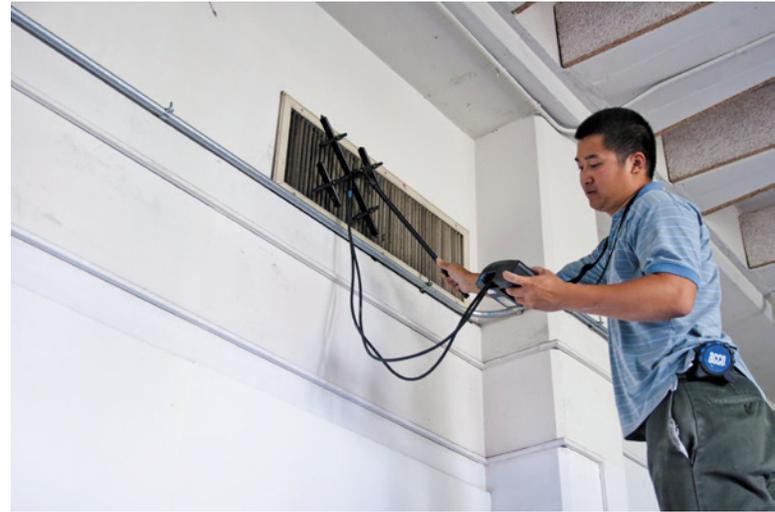
Figure 3: Pre-install testing and recording of flow rates from each of the registers in the building

To validate these modelled results, comparisons were made to actual measured leakage rates measure during operation. To do this the full speed airflow rate was measured using a duct traverse method at each air handler prior to the duct sealing. The flow rate measured at the air handler was then compared to airflow measured at all the diffusers to determine actual leakage rates. (Table 3).
